NATIONAL ADVISORY COMMITTEE FOR AERONAUTICS

TECHNICAL NOTE No. 842

TIDEWATER AND WEATHER-EXPOSURE TESTS ON METALS

USED IN AIRCRAFT - II

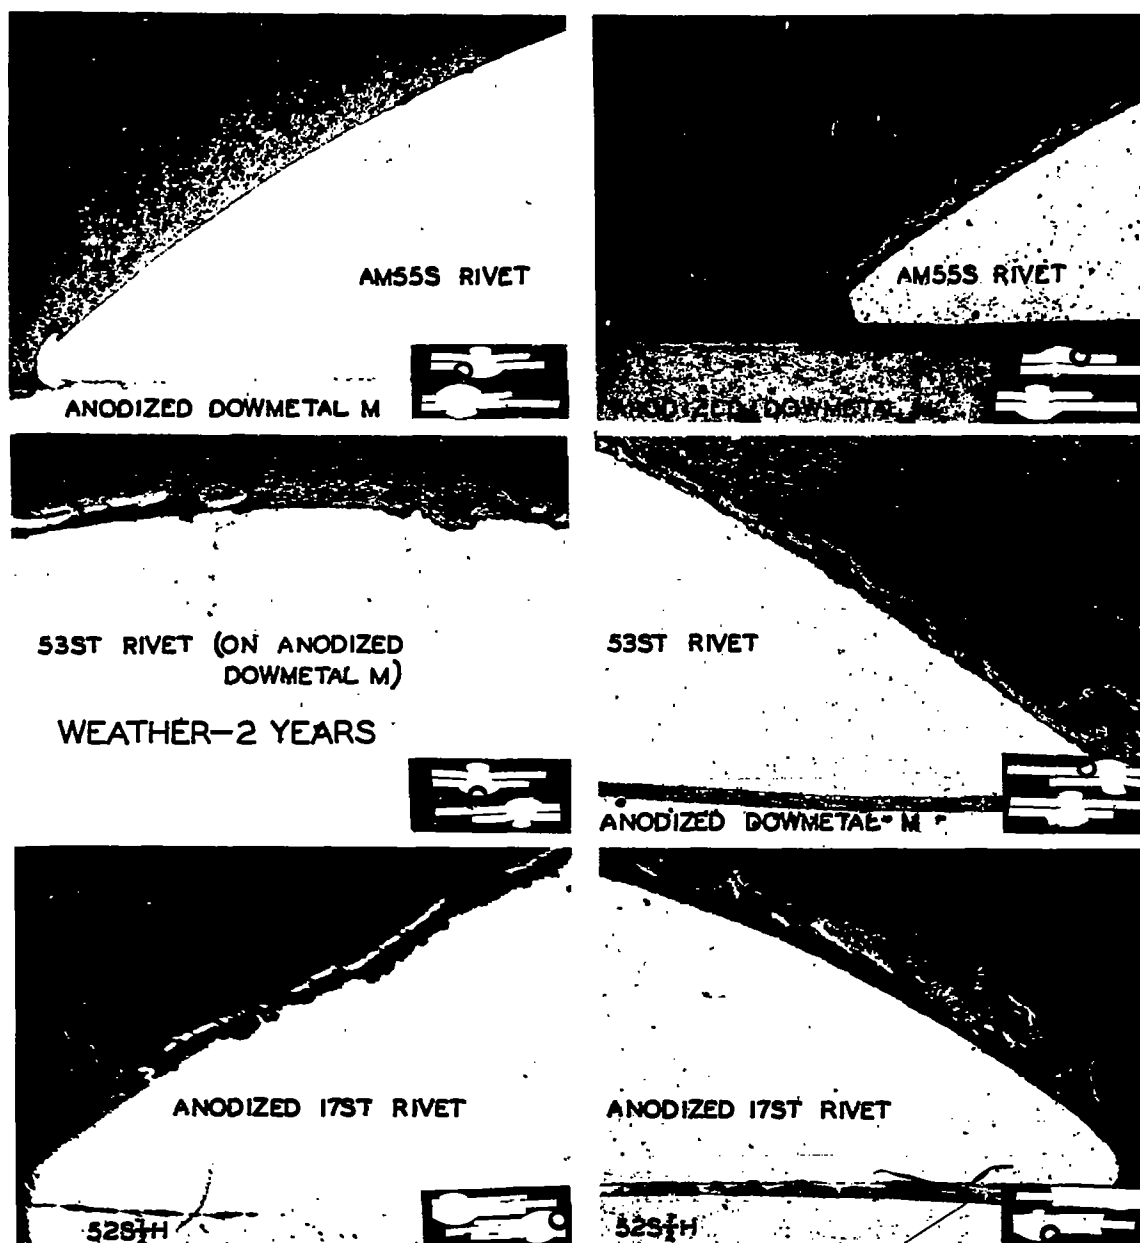
Figure 8.- Corrosion on rivets used for joining Dowmetal M sheets. Attack was least on the unanodized AM55S, intermediate on the 53ST, and most on the anodized 17ST rivets on unpainted panels. None of the rivets on painted panels were corroded. Micrographs, x 40; cross-sections, x 1.

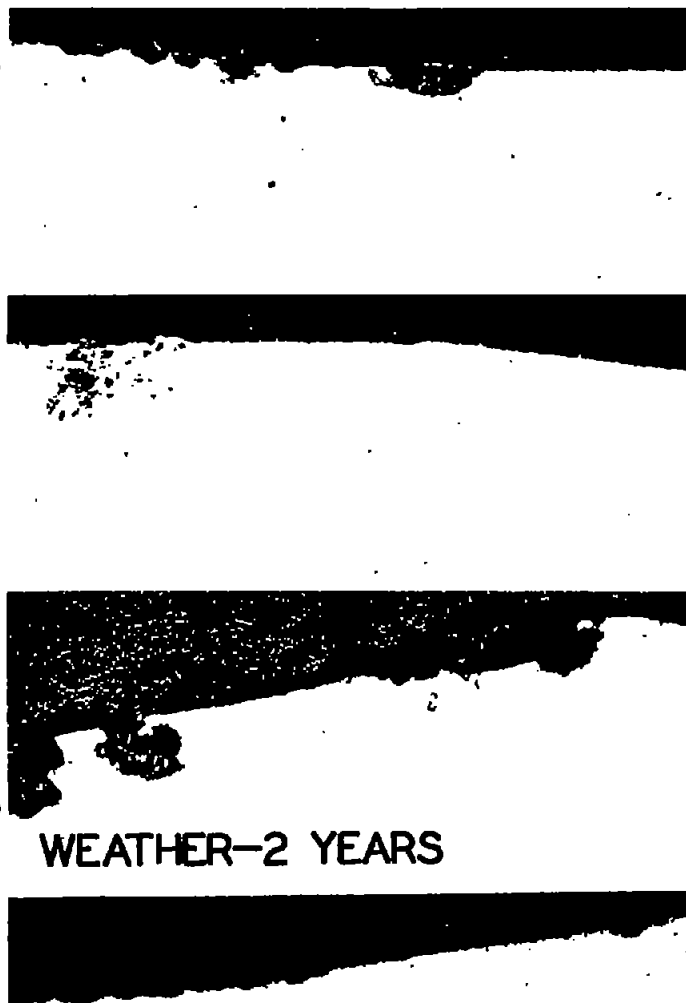
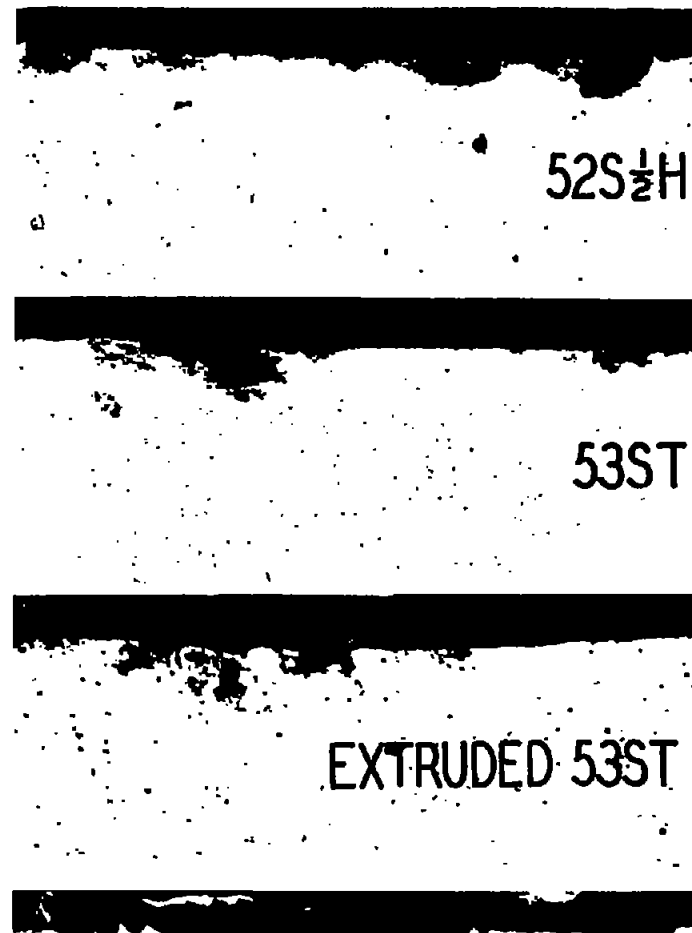
The microscopic examinations (figs. 12 and 13) of the spot welds disclosed many pits (0.001 and 0.002 in.) on the Alclad 24ST panels, but in no case was penetration of the aluminum protective coating found. On 52S- $\frac{1}{2}$ H welds numerous pits were found associated with some intercrystalline attack, generally 0.002 inch deep, but occasionally 0.006 inch. The welds on the sheet and extrusions of 53ST alloy were attacked similarly to those on 52S- $\frac{1}{2}$ H but intercrystalline attack was more in evidence; and occasionally pit depths of 0.010 inch were noted. Little attack occurred at the faying surfaces, but some pits 0.005 inch deep were detected on the 53ST materials.

On the seam welds the attack was somewhat more severe. The aluminum coating on the Alclad 24ST panels was penetrated in some instances and the attack reached a depth of 0.004 inch, as it did also on the 52S- $\frac{1}{2}$ H welds. Seam welds on the 53ST alloys were occasionally corroded to depths from 0.007 to 0.012 inch. The gas welds proper showed but slight attack. At the junction of the weld metal with the unwelded parts of the sheets, however, corrosion sometimes attained a depth approximating 0.004 inch.

Figure 12.- Microscopic examination of welds on aluminum-alloy panels exposed to the weather revealed considerable corrosion of greater depth than occurred on unwelded portions. Seam welds were the most severely attacked. Corrosion on welds on Alclad 24ST was

shallower than on the other alloys but penetrated the protective aluminum coating in some instances. x 50.

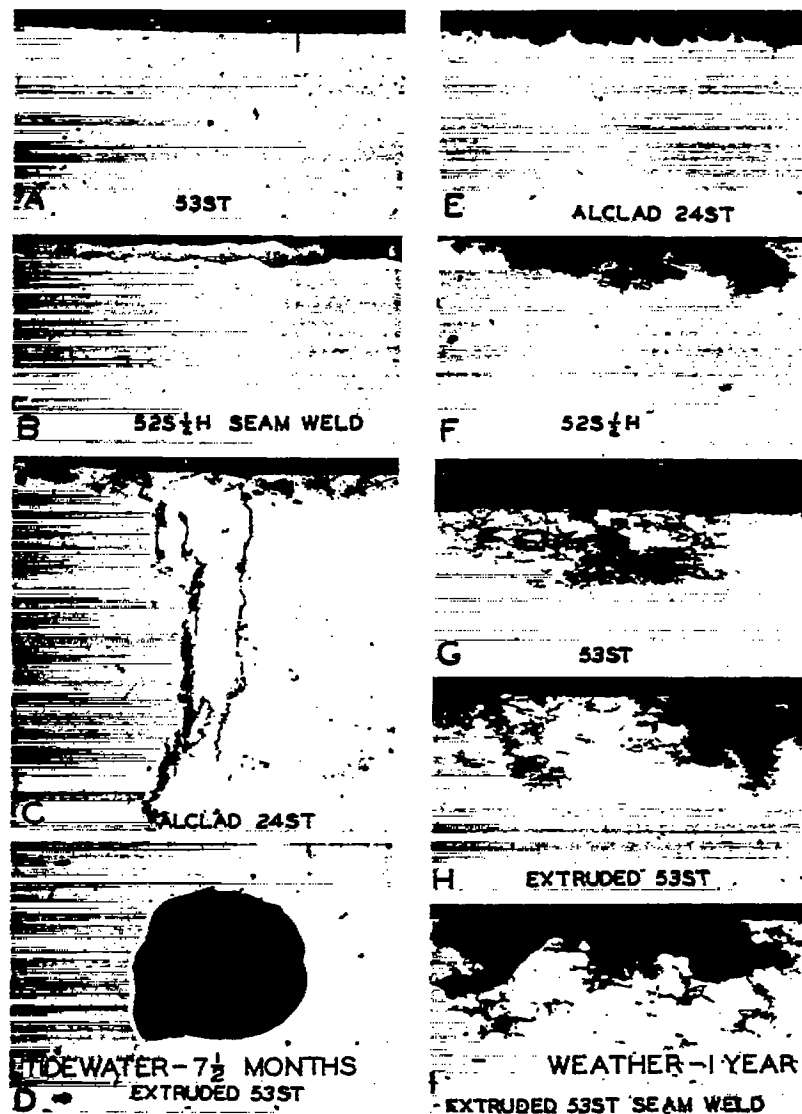
The seam welds were uniformly sound, but cracks occurred on some of the Alclad 24ST spot welds (fig. 13); whereas very small cavities, 0.001 inch in diameter, were present on a few of the 52S- $\frac{1}{2}$ H welds and cavities as wide as 0.010 inch were found in several of the welds on extruded 53ST panels. Numerous cavities, ranging from 0.005 to 0.010 inch in diameter, were found in the gas welds.

Figure 13.- Photomicrographs of welds on aluminum-alloy panels exposed to weather or to tidewater. Spot welds are pictured, unless otherwise noted. A - Formative stage of intercrystalline corrosion. B - Coating on weld, perhaps resulting from reaction with the electrode. C - Cracks present in some of the spot welds in this alloy. D - Cavity, representative of those of average size found in some spot or gas welds. E - Pitting, though general, had not penetrated the aluminum protective coating during the first year. F - Traces of intercrystalline attack were occasionally associated with pits on the 52S- $\frac{1}{2}$ H alloy. G - Intercrystalline corrosion on an area of the sheet remote from a weld. H and I - Intercrystalline corrosion on welds. x 60.

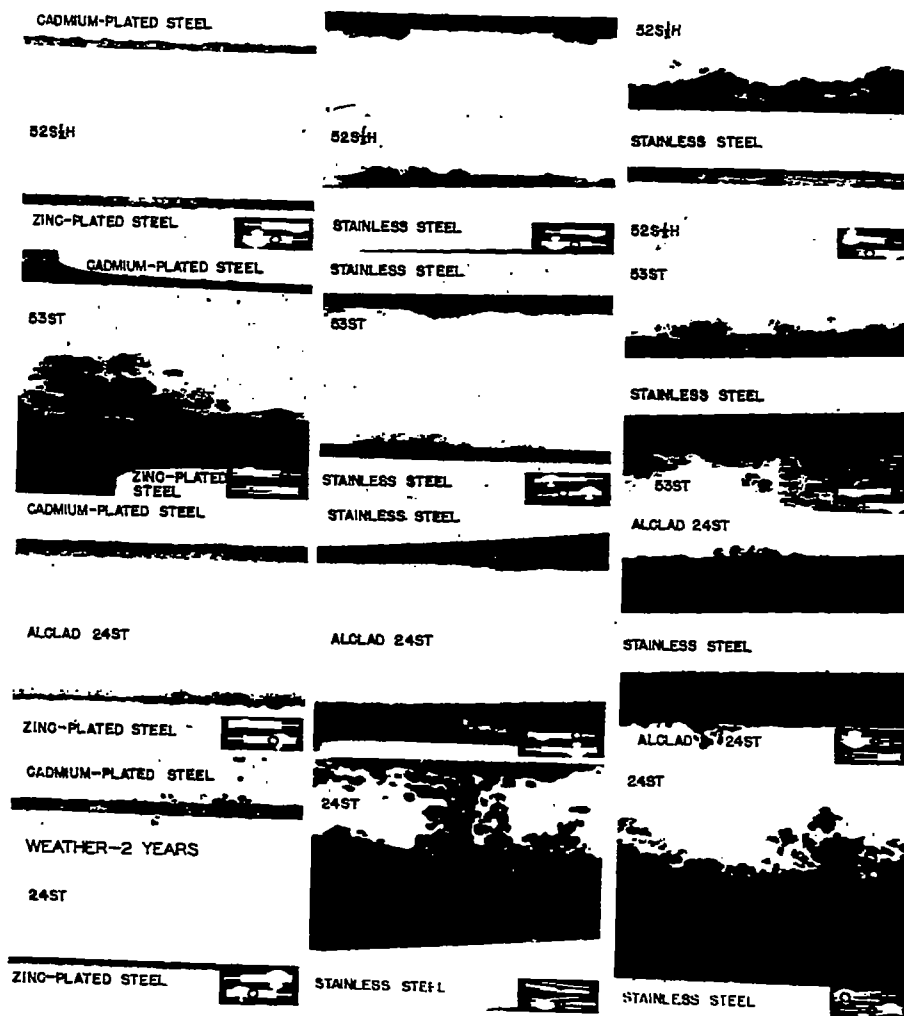
Figure 19.- Cross section showing aluminum alloys exposed to the weather in contact with electrodeposited coatings of cadmium and zinc or with stainless steel. Attack at the faying surfaces was usually deepest on the main panel at areas near the edges of the strips, especially when corrosion products were present in quantity. Photomicrographs,  $\times 25$ ; smaller cross sections,  $\times 1/2$ .

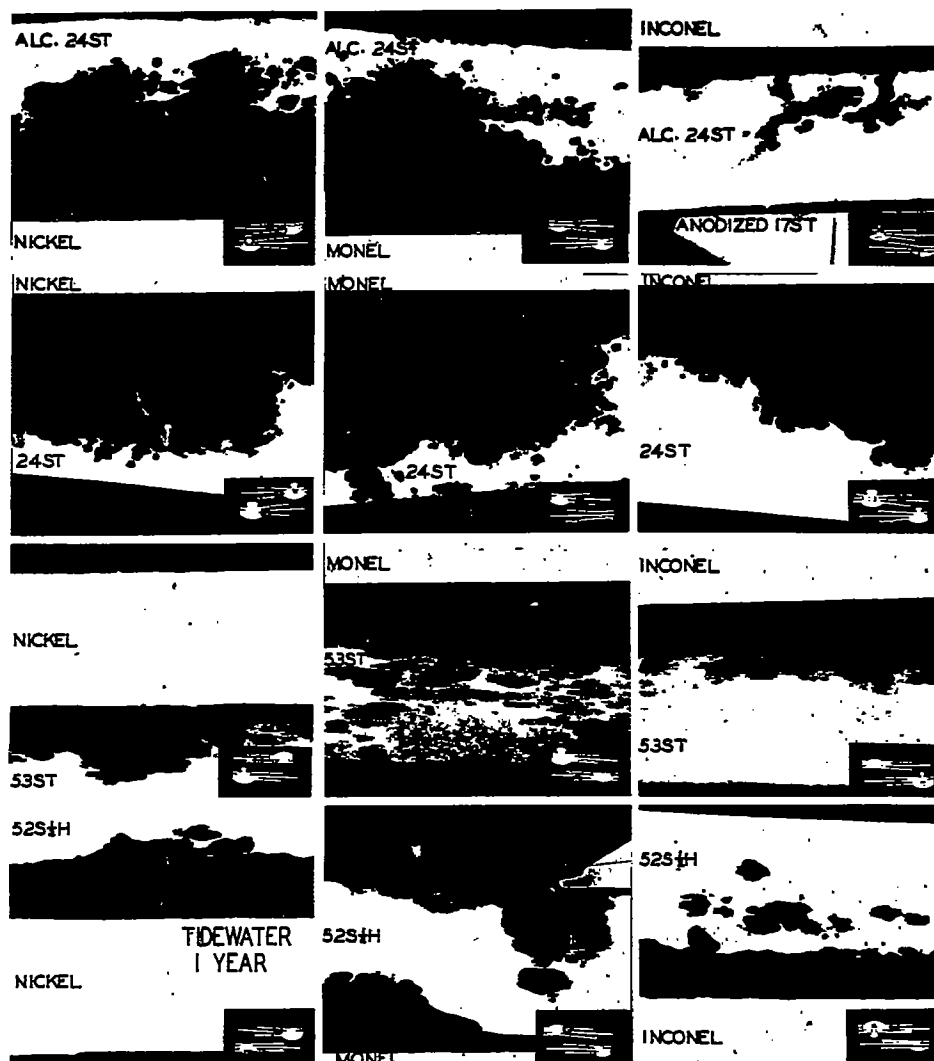
Contacts of aluminum alloys with nickel alloys.-- The aluminum alloys formed the 1- by 4-inch strips attached to main panels of nickel, monel metal, or Inconel. Microscopic examinations of the panels exposed for 1 year to tidewater (fig. 20 and table II) indicated that the aluminum alloys were probably more anodic to the nickel alloys than to the stainless steels. Monel-aluminum alloy couples resulted in the worst corrosion on aluminum, but the corrosion was sufficiently severe with all these combinations to indicate that coupling with these nickel alloys should be avoided. Cracks resulting from the combined action of stresses and corrosion were found on all strips of 24ST and Alclad 24ST in contact with these alloys.

Figure 20.- Cross sections showing nickel alloy panels exposed to tide-water in contact with aluminum alloys. Attack on the aluminum alloys was very severe in every instance. Note the stress-corrosion cracking on the Alclad 24ST strips joined to Inconel (upper right corner). Photomicrographs,  $\times 25$ ; smaller cross sections,  $\times 1\frac{1}{2}$  (17).

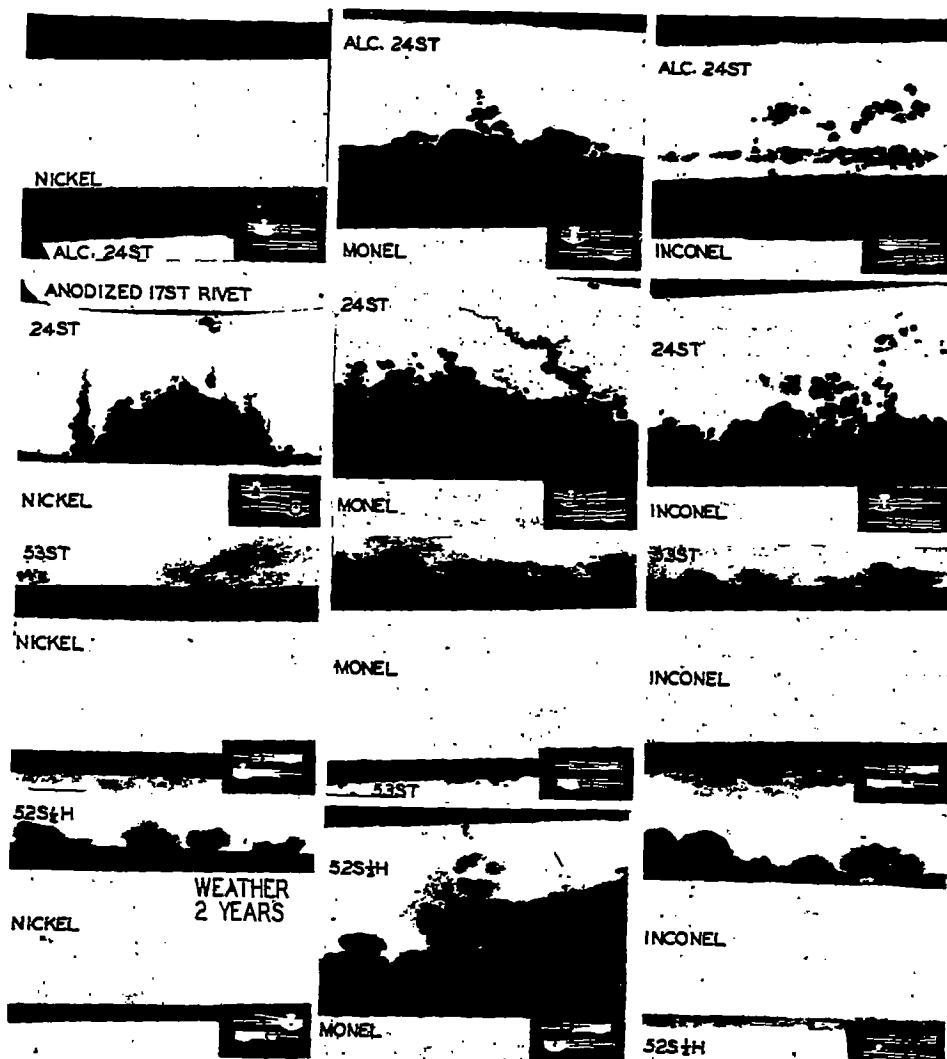
Figure 22.- Cross section showing nickel alloy panels exposed to the weather in contact with aluminum alloys. Compare with Figure 20. Note cracks on 24ST strips in contact with nickel and monel metal. Photomicrographs,  $\times 25$ ; small cross section,  $\times 1/2$ .

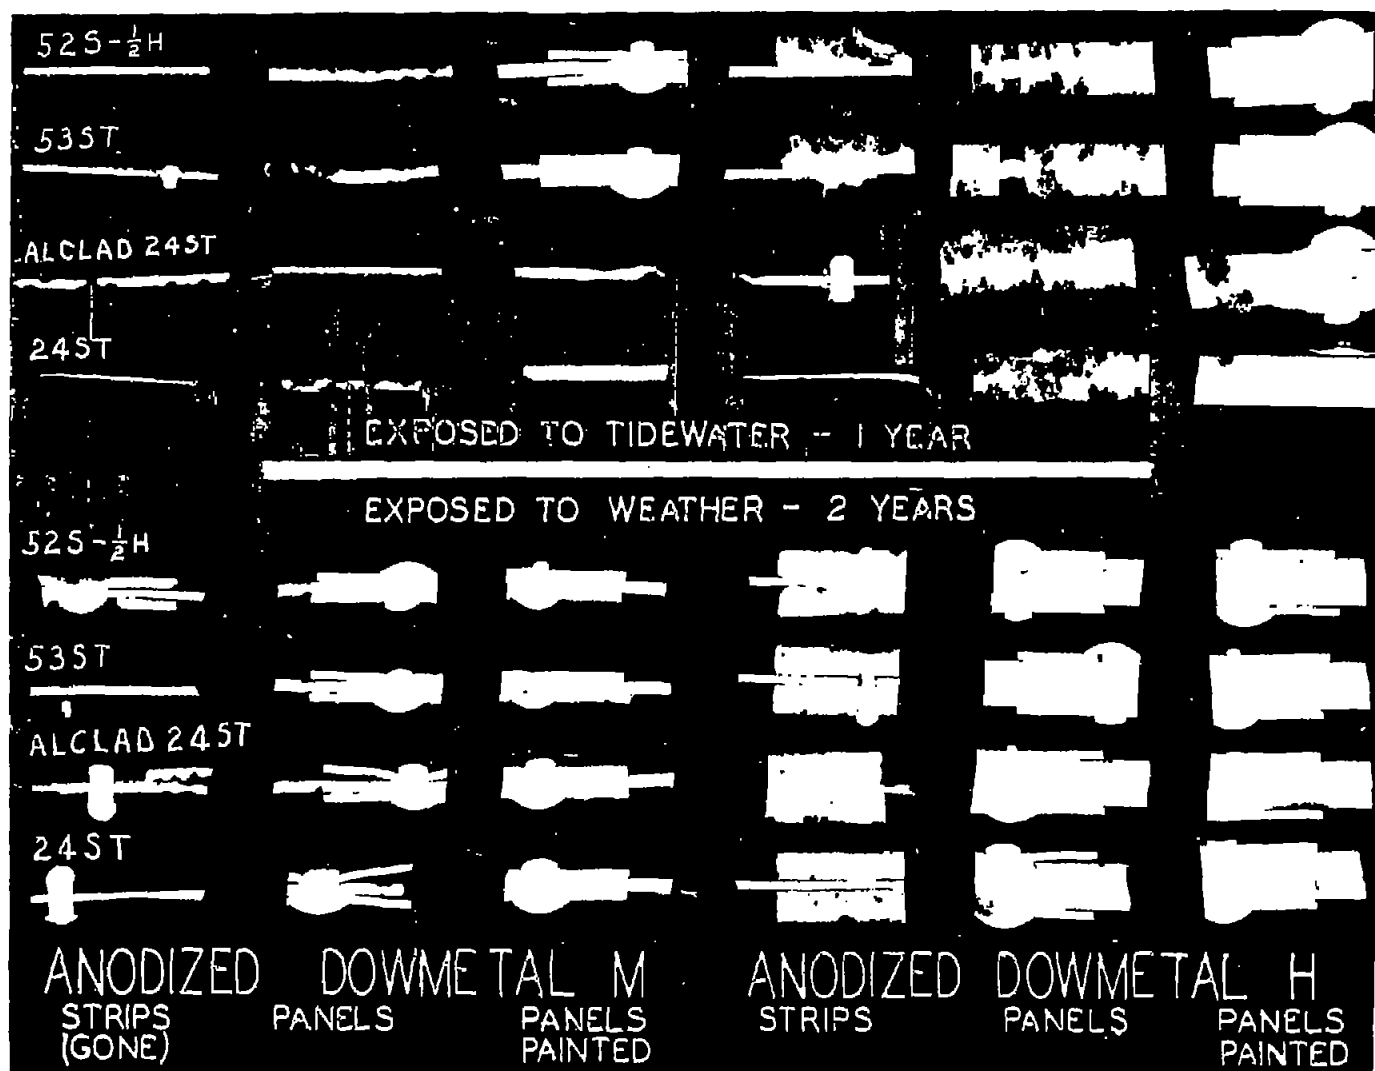
posed to the weather (fig. 23), but the painted panels were in relatively good condition after 2 years (figs. 23, 24, and 25). The panels were painted with 1 coat of Watson Standard Dowmetal Primer No. 1 plus 3 coats of Brooklyn Varnish No. 74 pigmented with  $1\frac{1}{2}$  pounds of aluminum paste per gallon. The photographs illustrate that corrosion was much less severe where Dowmetal H, instead of Dowmetal M, was coupled with the aluminum alloys.

Figure 23.- Cross sections showing aluminum alloys exposed to tidewater and to the weather in contact with magnesium alloys. The magnesium alloys were the strips attached to larger areas of aluminum alloys in the first and fourth vertical columns; in the other vertical columns the aluminum alloys were the strips. Panels in the tidewater tests were in advanced stages of disintegration, except when painted. Unpainted panels with Dowmetal M strips were also severely attacked in the weather. x 1 (18).

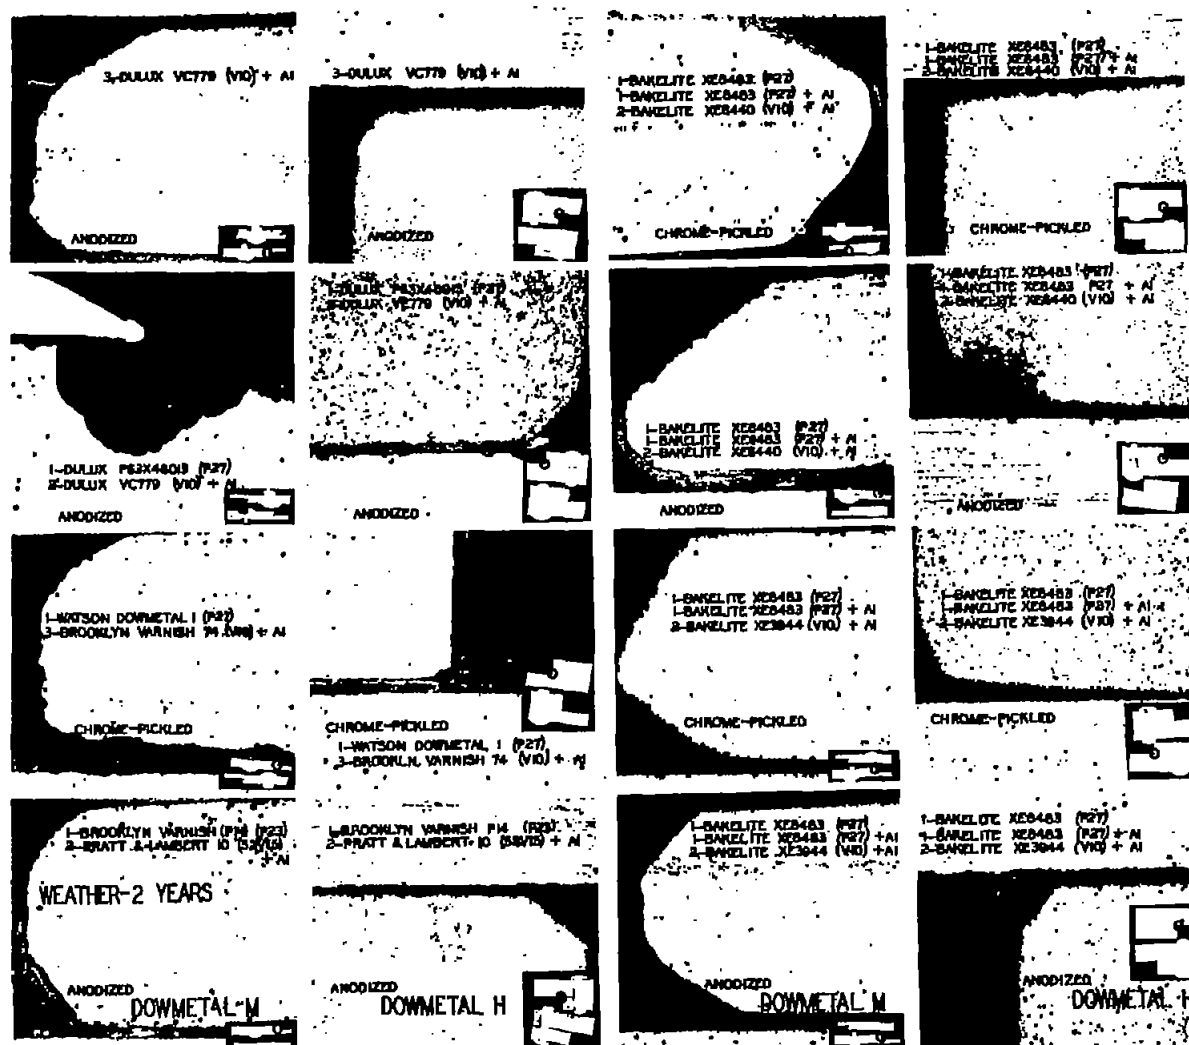
In the weather-exposure tests, at the end of the second year, most of the paints were in good condition (fig. 28). Failures were generally confined to the unanodized AN55S rivet heads and to the edges of the panels. Microscopic examinations (fig. 29) revealed occasional deep pits at areas adjacent to rivet heads.

Figure 29.- Cross sections of magnesium alloys exposed to the weather with various protective paint coatings. Edges of strips were purposely rounded prior to painting. Much of the corrosion present occurred on these edges or at areas of paint failure adjacent to the AM55S rivet heads. Photographs,  $\times 25$ ; smaller cross sections,  $\times 1/2$ .

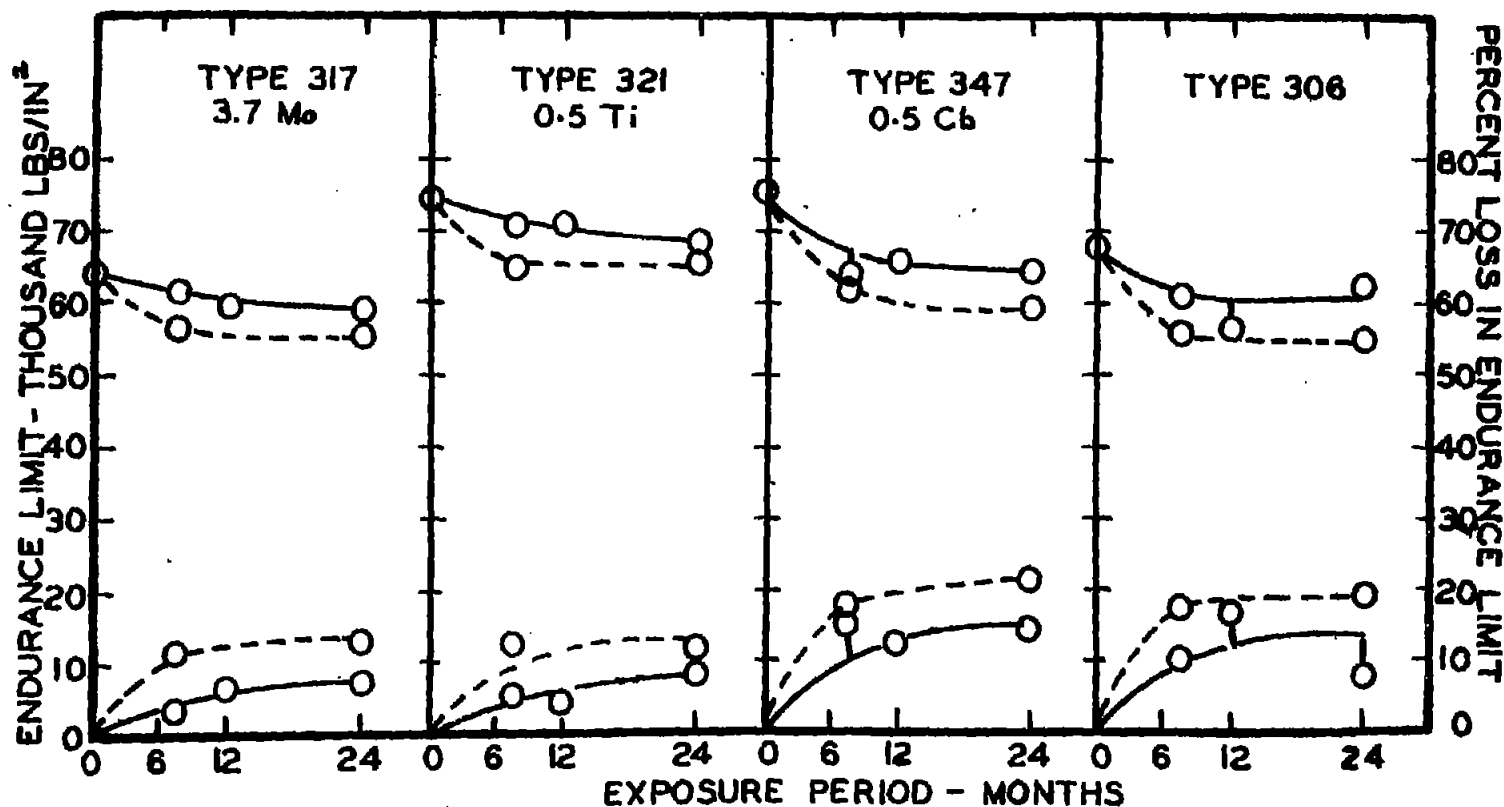
The fatigue tests disclosed that steels exposed to the weather consistently showed greater loss in endurance limit than when exposed to tidewater for the same period of time. The steels containing 3.7 percent molybdenum or 0.5 percent titanium behaved similarly and both exhibited appreciably less loss in endurance limits than did the ordinary 18:8 steel or one containing 0.5 percent columbium. The results illustrate that the greater part of the losses for all the steels occurred during the first year of exposure and that the rate of corrosion decelerated during the second year.

Figure 32.- Results of flexural fatigue tests on stainless steel. Solid line curves pertain to specimens exposed to tidewater; broken-line curves pertain to specimens exposed to the weather. The upper curves, in each instance, refer to values for endurance limits; the lower curves to percentage loss. Panels exposed to the weather consistently showed greater loss than those exposed to tidewater for equal periods. Steels containing molybdenum or titanium exhibited appreciably lower losses than those with columbium, or with no elements added to the typical 18 percent chromium, 8 percent nickel alloy (Type 306).
